# ORBITER TILE IMPACT TESTING

Final Report

SwRI Project No. 18-7503-005

NASA  
Johnson Space Center  
Houston, Texas

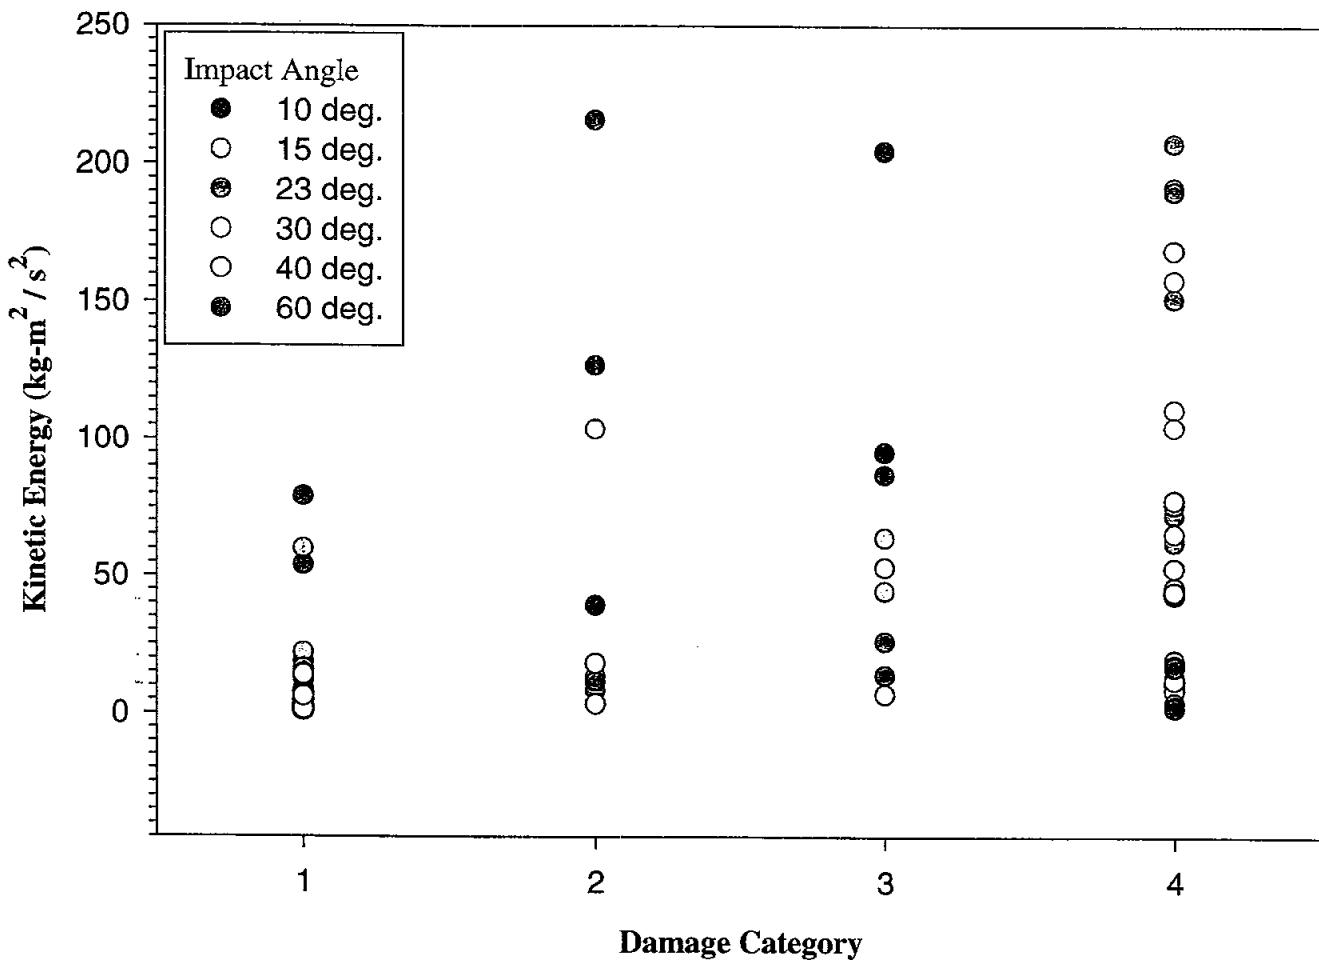
**Figure No. 8: Projectile Kinetic Energy vs. Damage Category**

Figure No. 8 is a plot of the resulting tile damage level or category (1 – No Damage, 2 – Cracking and Delamination of the Coating, 3 – Shallow Crater, 4 – Crater) as a function of the foam projectile kinetic energy. The plot shows a general trend where the level of damage (category) increases as kinetic energy and/or incidence angle are increased. As the incidence angle reaches 60 degrees, projectiles with relatively low kinetic energy (3/8" diameter projectile in this case) can inflict high levels of damage on the tile target.

In the plots shown in Figures No. 8, No. 9, and No. 10 there is a degree of mixed results where definite conclusions are difficult to make. The cause of the mixed results in the plots is mainly attributed to the grouping together of the data from the various shaped projectiles and due to the inherent randomness in the penetration/failure events in brittle or soft targets.

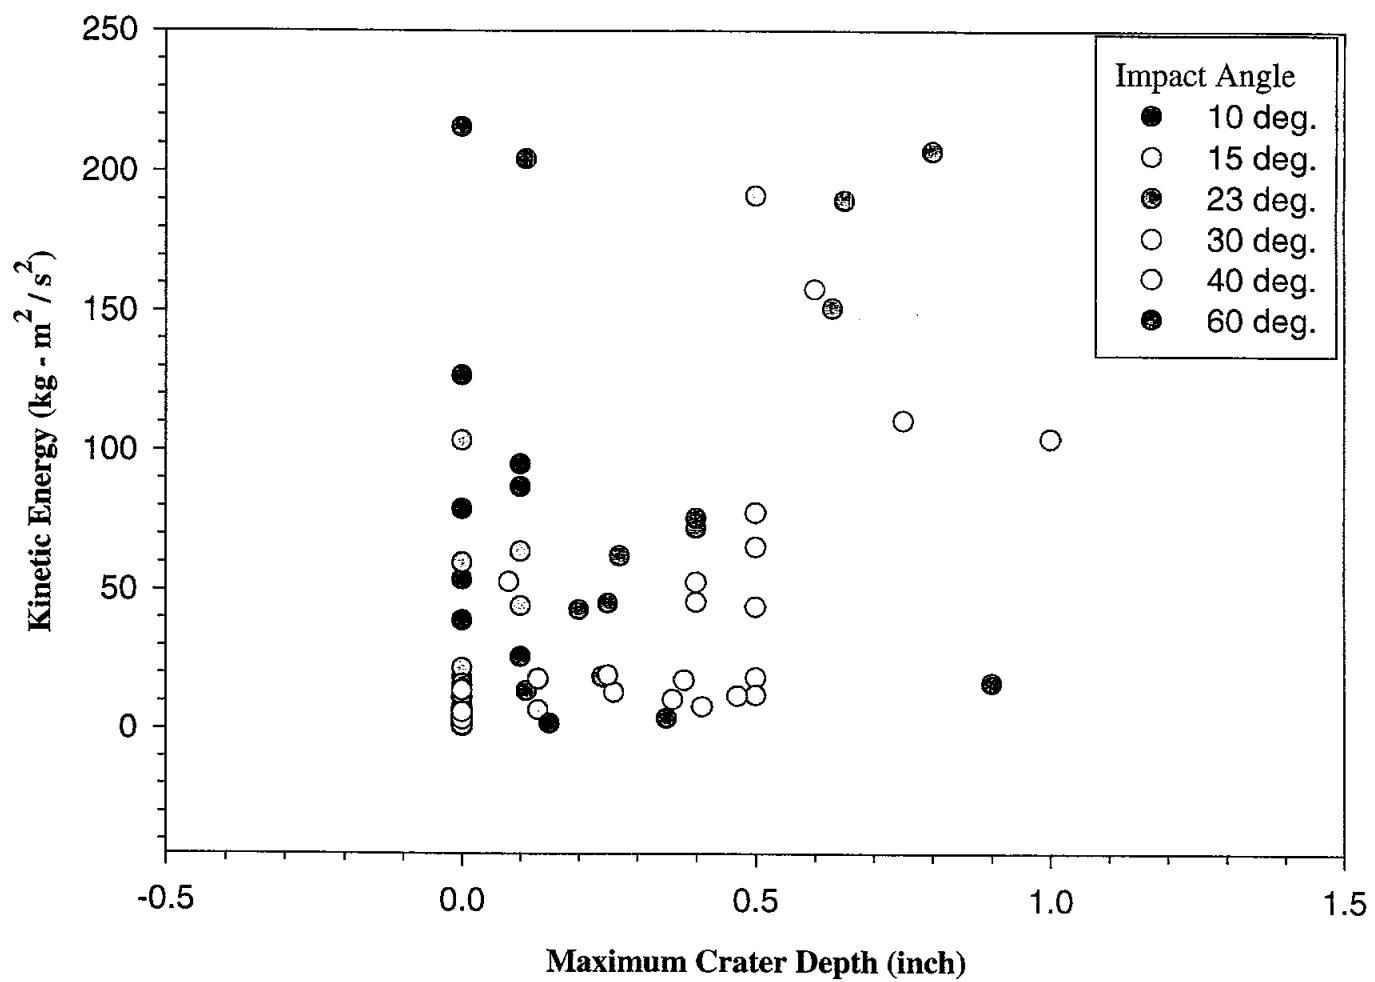
Figure No. 9: Projectile Kinetic Energy vs. Max. Crater Depth

Figure No. 9 is a plot of maximum crater depth as a function of projectile kinetic energy. In general, as the incidence angle of impact is increased, crater depth increases. For a given incidence angle, crater depth increases as kinetic energy increases.

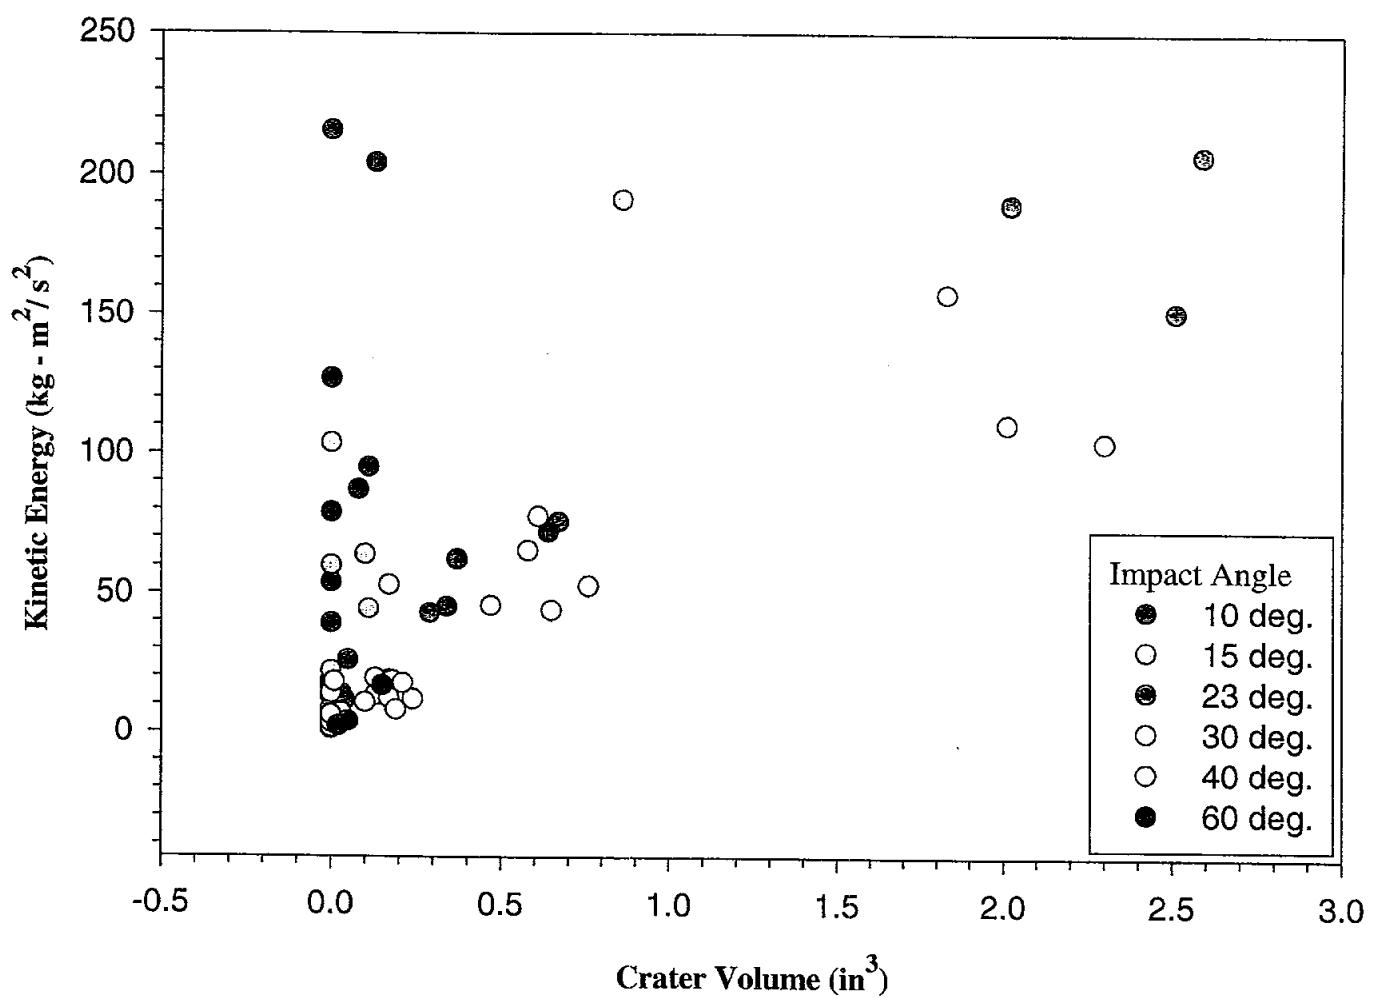
Figure No. 10: Projectile Kinetic Energy vs. Crater Volume

Figure No. 10 is a plot of crater volume as function of projectile kinetic energy. In general, crater volume increases as the incidence angle and/or kinetic energy are increased. As expected, tests conducted with large fast moving projectiles fired at increased incidence angles produced the largest crater volumes. Note that in several tests, the crater extended to the edge of the tile target. Thus the total possible crater volume could not be determined. Such tests are labeled with a “\*\*” symbol in the damage dimension column of the results tables. The data point for Test No. 60 in which the 1" x 1" x 3" projectile was launched at a 40 degree angle at 1432 fps is not included in the plot of Figure No. 10. The damage was too extensive to accurately measure volume.

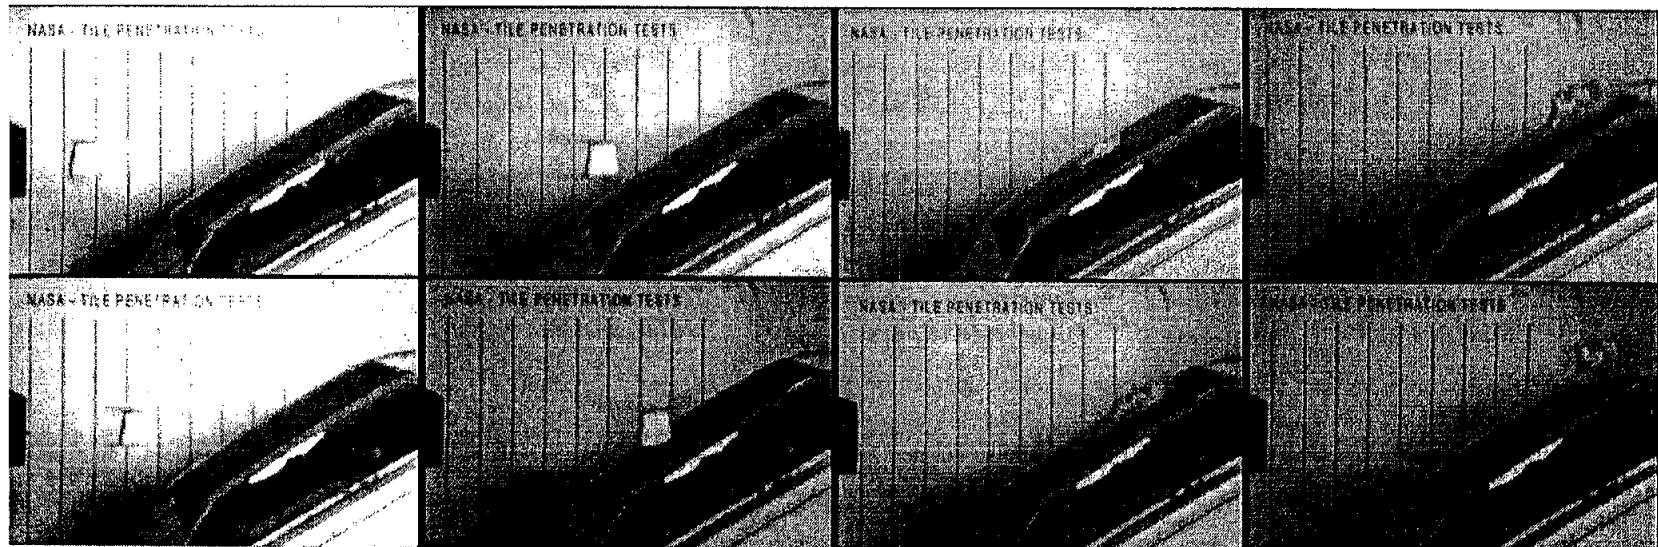
**Test No. 35**

32	1557	23	Yes	Crater	3.75" x 1.5" x 0.4"	Velocity (-43 fps)	0.64
33	452	30	No	*****	*****	Velocity (+52 fps)	*****
34 (A)	805	30	Yes	Crater	2.0" x 1.25" x 0.25"	Velocity (+5 fps)	0.13
35	1240	30	Yes	Crater	2.25" x 1.38" x 0.4"	Velocity (+40 fps), Projectile Cracked	0.47
36 (A)	1483	30	Yes	Crater	2.5" x 1.5' x 0.5"	Velocity (-117 fps), Projectile Slightly Broken Up	0.58
37	447	40	No	*****	*****	Velocity (+47 fps)	*****
38	767	40	Yes	Crater	1.5" x 1.25" x 0.38"	Velocity (-33 fps), Projectile lost a small piece	0.21
39	1216	40	Yes	Crater	2.5" x 1.1" x 0.5"	Velocity (+16 fps)	0.65
40 (A)	1616	40	Yes	Crater	3.0" x 1.5" x 0.5"	Velocity (+16 fps), Projectile Slightly Broken Up	0.61
83	790	10	No	*****	*****	Velocity (-10 fps)	*****
84 (B)	1710	10	Yes	Shallow Crater, loss of Coating	**2.25" x 1.63" x 0.10"	Velocity (+110), Extended to Tile Edge	0.08
91	794	23	Yes	Crater	1.7" x 1.21" x 0.24"	Velocity (-6 fps)	0.17

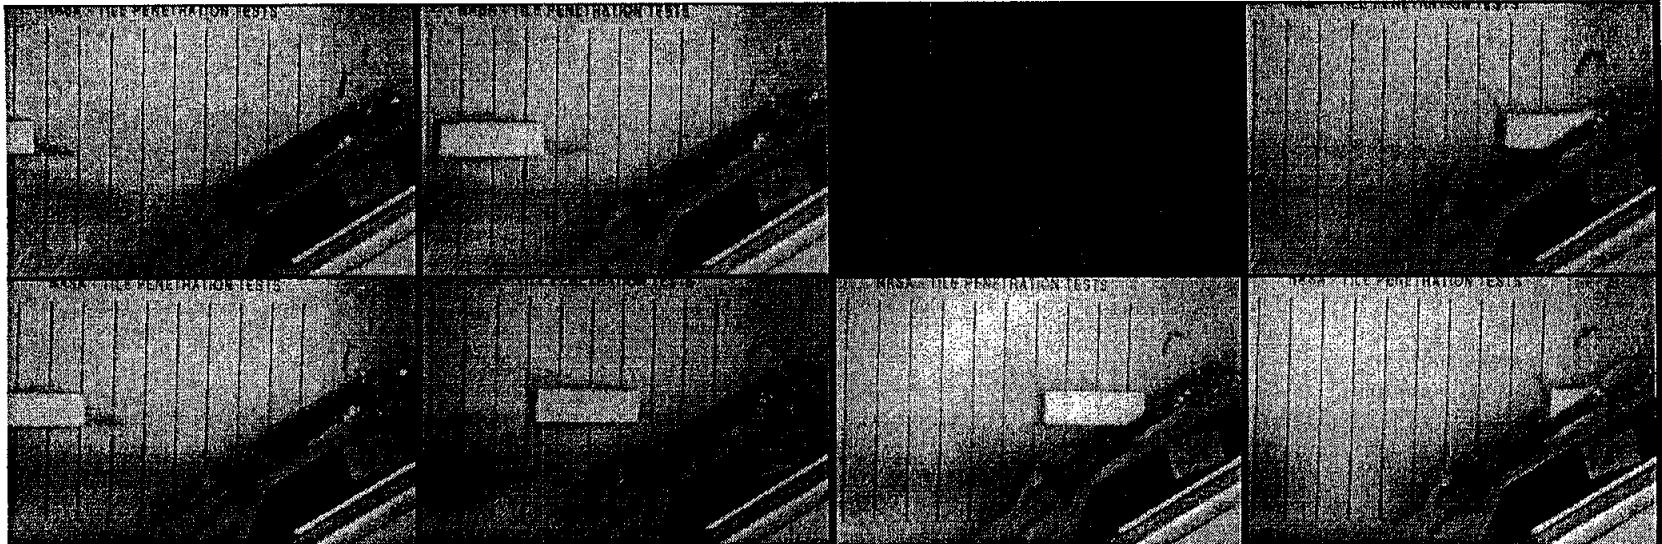
**Test No. 54**

54	1" x 1" x 3"	803	30	Yes	Crater	2.0" x 1.25" x 0.08"	Velocity (+3 fps)		0.17
55	1" x 1" x 3"	1161	30	Yes	Crater	"3.65" x 1.5" x .75"	Velocity (-39 fps), Extended to Tile Edge		2.01
56	1" x 1" x 3"	1386	30	Yes	Crater	4.13" x 2.75" x 0.6"	Velocity (-214 fps), Projectile Slightly Broken Up		1.83
57	1" x 1" x 3"	-400	30	No	*****	*****	No Imacon, Guess on Velocity		*****
*57A	1" x 1" x 3"	467	40	Yes	Delamination and Cracking of Coating	0.75" diameter x 0.13" deep	Velocity (+67 fps)		0.01
58	1" x 1" x 3"	801	40	Yes	Crater	2.5" x 1.2" x 0.4"	Velocity (+1 fps)		0.76
59	1" x 1" x 3"	~1200	40	Yes	Crater	"4.0" x 3.0" x 2.0"	No Imacon, Guess on Velocity		*****
*59A	1" x 1" x 3"	1126	40	Yes	Crater	4.5" x 2.0" x 1.0"	Velocity (-74 fps)		2.30
60	1" x 1" x 3"	1432	40	Yes	Crater	"6.0" x 3.0" x 2.0"	Velocity (-168 fps), Projectile Broke Up		*****
81	.89" x .89" x .25"	750	10	No	*****	*****	Velocity (-50 fps)		*****
